**THE CALIFORNIA EARTHQUAKE OF APRIL 18, 1906**

**REPORT**

**OF THE**

ANDREW C. LAWSON

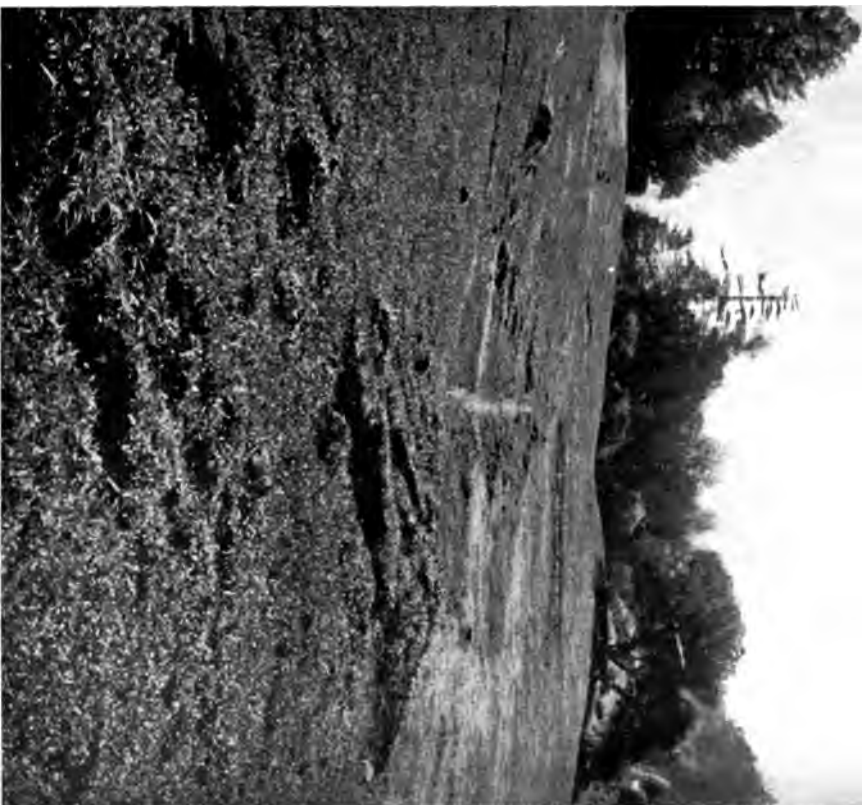
A. Fault-trace 1.5 miles south of Olema. Looking southeast. Trace touches both ponds, being best seen between them. G. K. G.

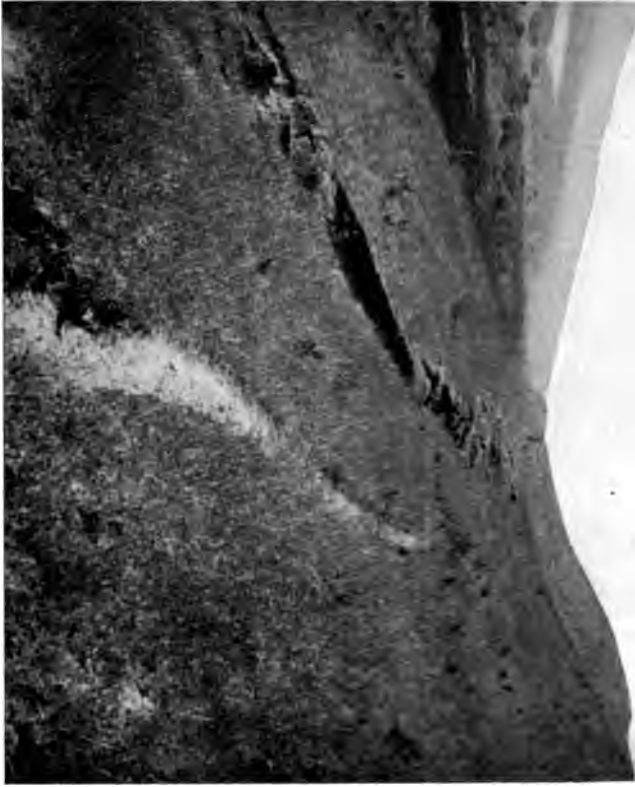
B. Looking southeast across hill-top a mile south of Olema. Shallow sag gives hill double crest and makes a pond basin. The fault-trace, both in foreground and beyond, is divided in several branches. G. K. G.

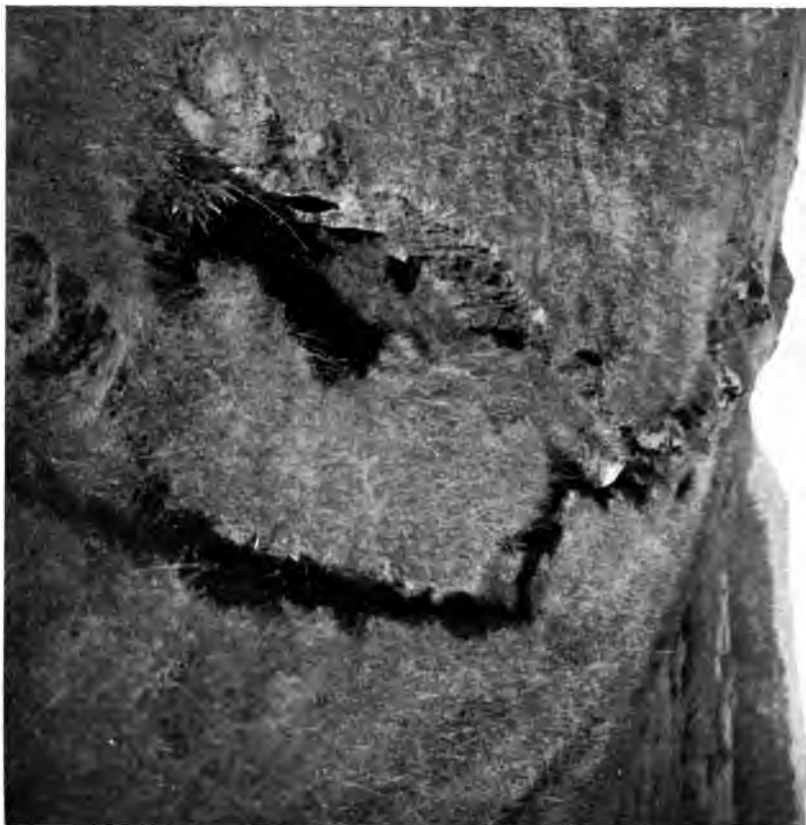
A. Fault-trace a mile northwest of Olema. Looking northwest. G. K. G.

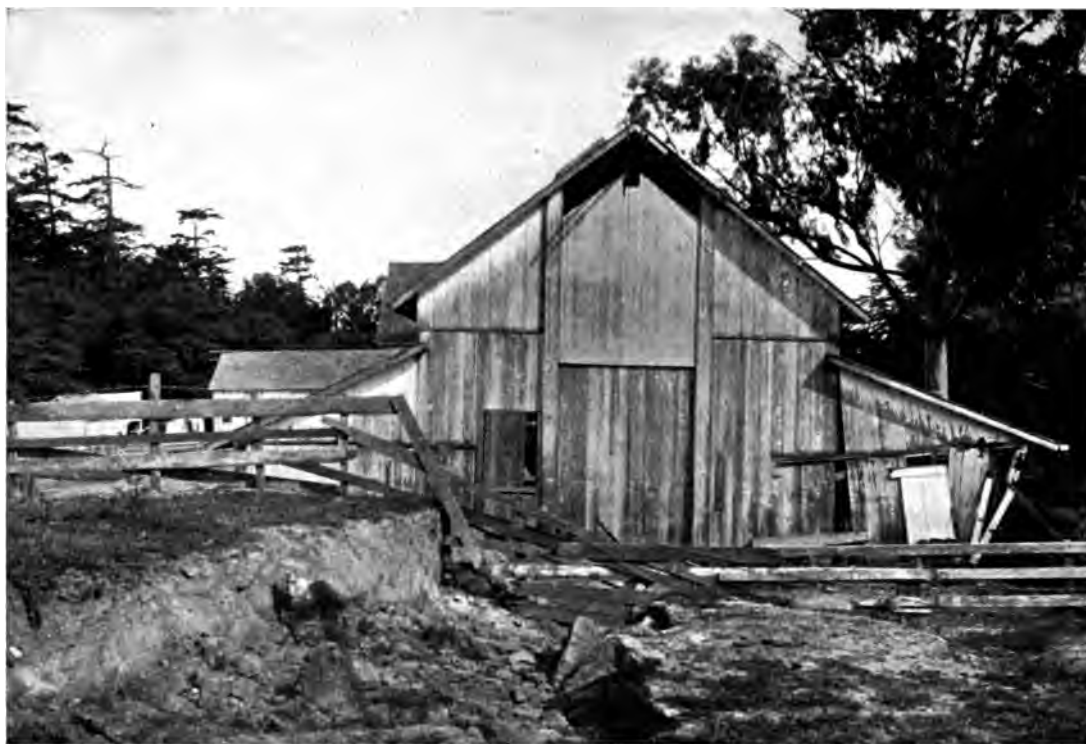
A. Fault-trace on Papermill delta. Looking northwest. G. K. G.

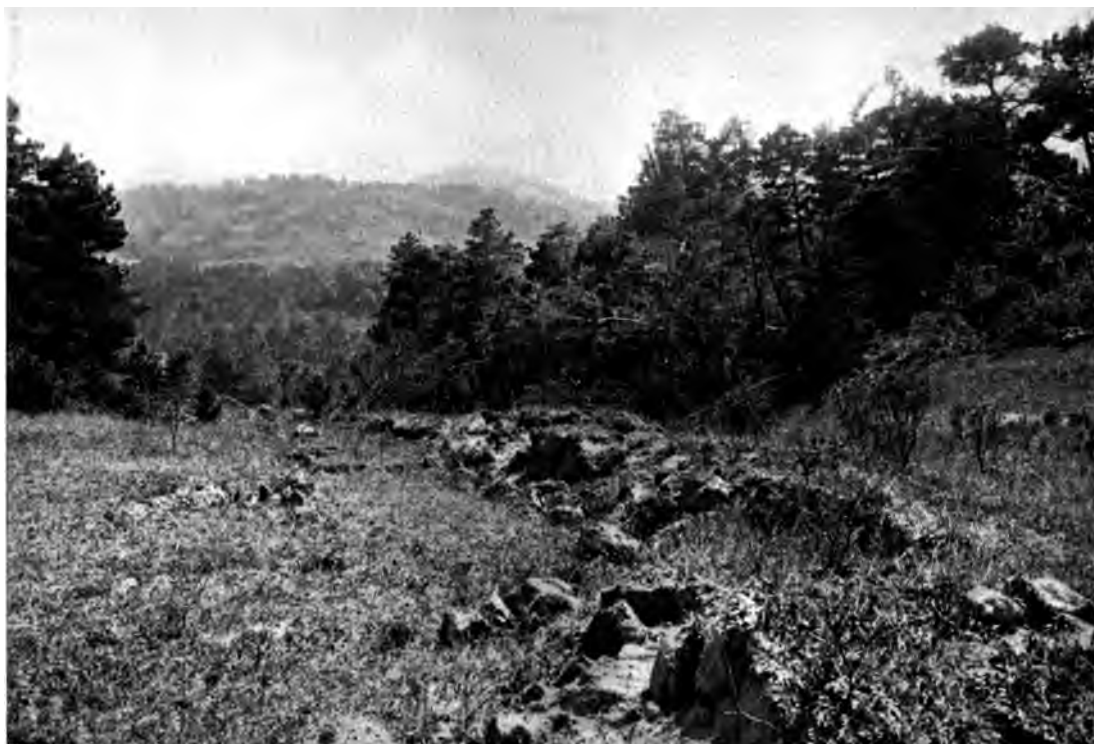
B. Fault-trace at the Skinner place, near Olema. Illustrating trench phase. G. K. G.

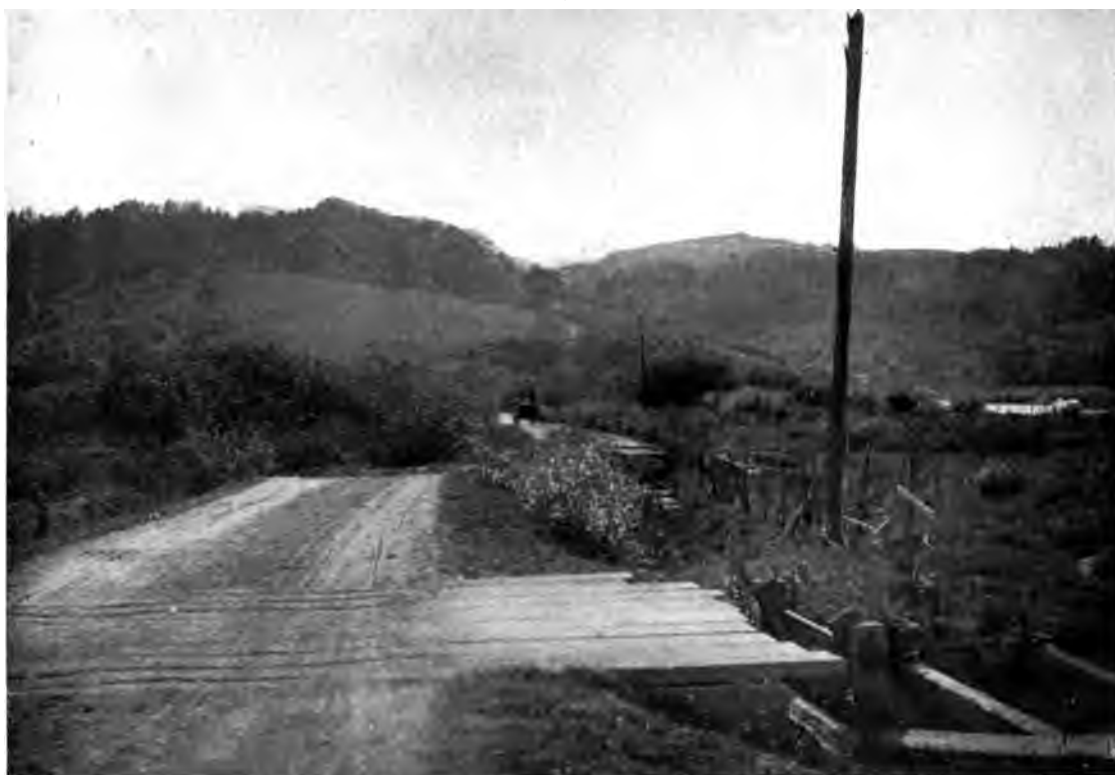
A. Branch of fault-trace on "north mesa" at Inverness. Looking southeast. G. K. G.

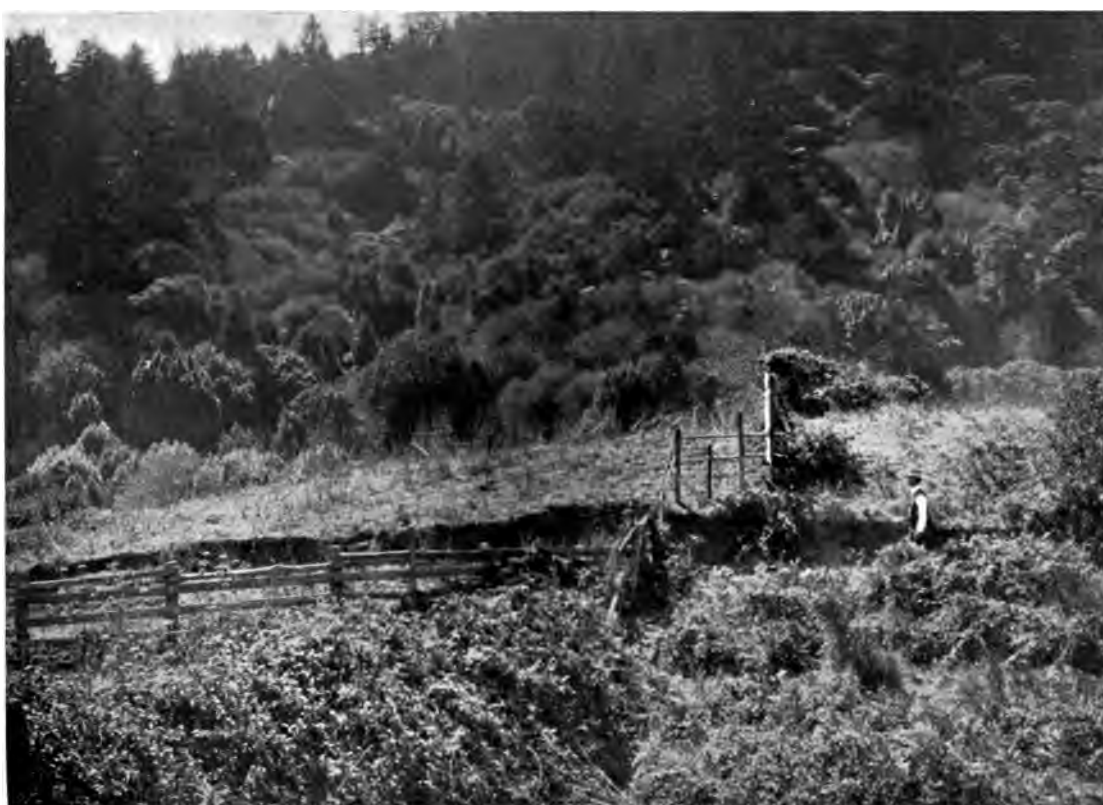
A. Fault-trace a mile northwest of Olema. Looking south. Appearance of vertical displacement largely due to combination of horizontal displacement with slope of ground. G. K. G.

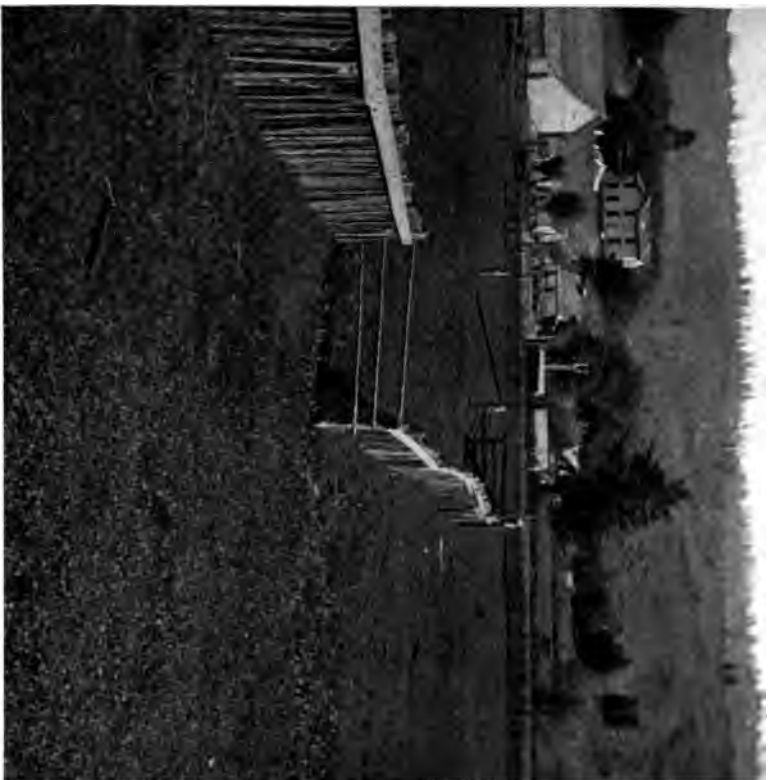
B. Fault-trace near Bondietti's ranch. Looking southwest. Shows vertical displacement bordering a sag. Horizontal displacement shown by fence, which had been repaired. G. K. G.

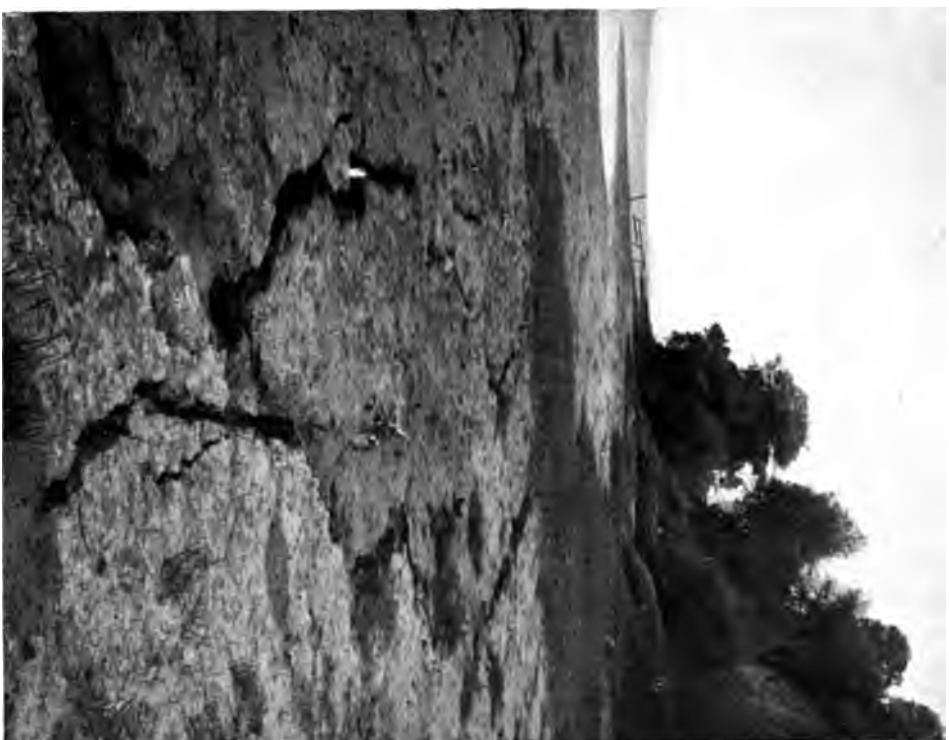
A. Fence offset by fault. Looking northwest. Camera was aimed with straight part of fence beyond the disturbance, to bring out flexure as well as offset of fence. G. K. G.

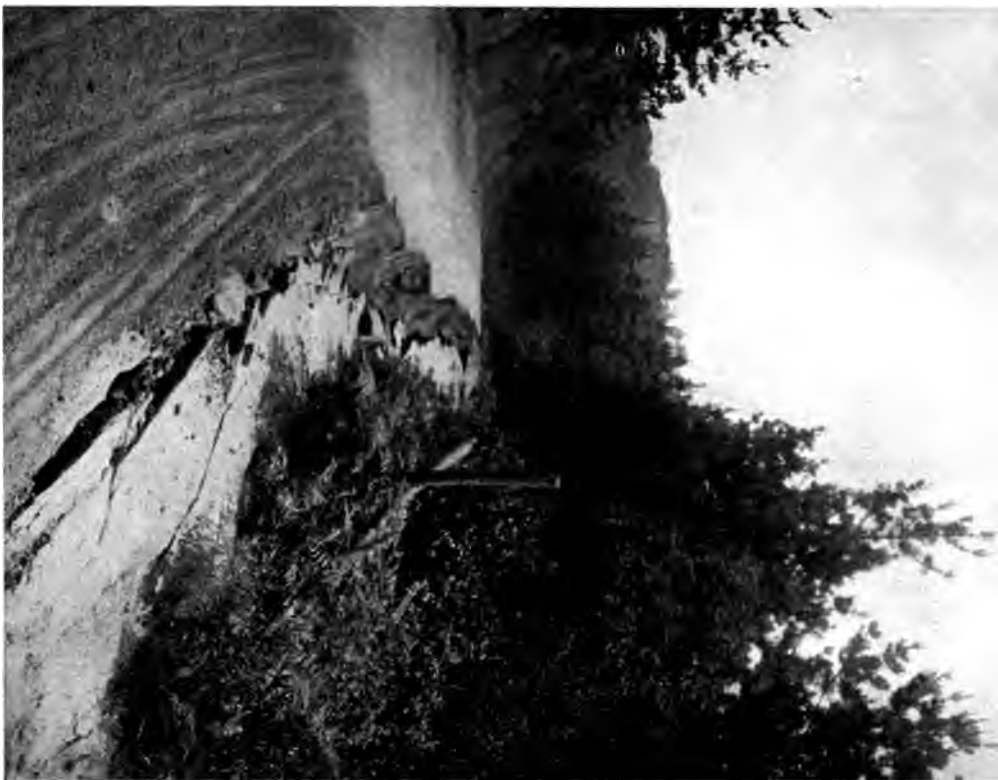
B. Faults in road embankment, southwest of Point Reyes Station. Fault-trace is beyond fence. Ground lurched toward marsh of Bear Valley Creek. G. K. G.

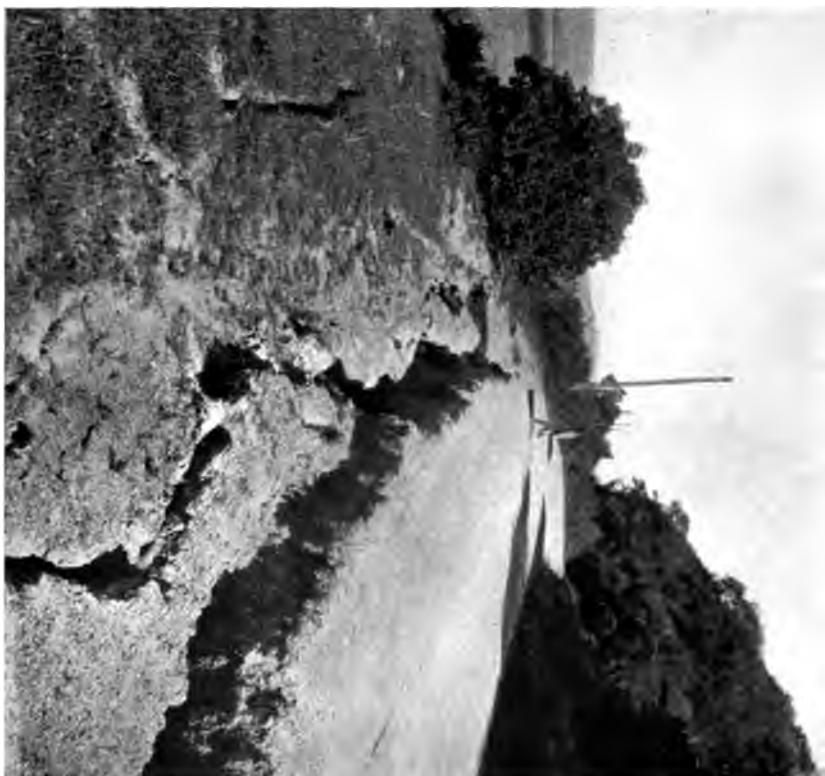
A. Roadside crack 2 miles west of fault, between Inverness and Point Reyes P. O. G. K. G.

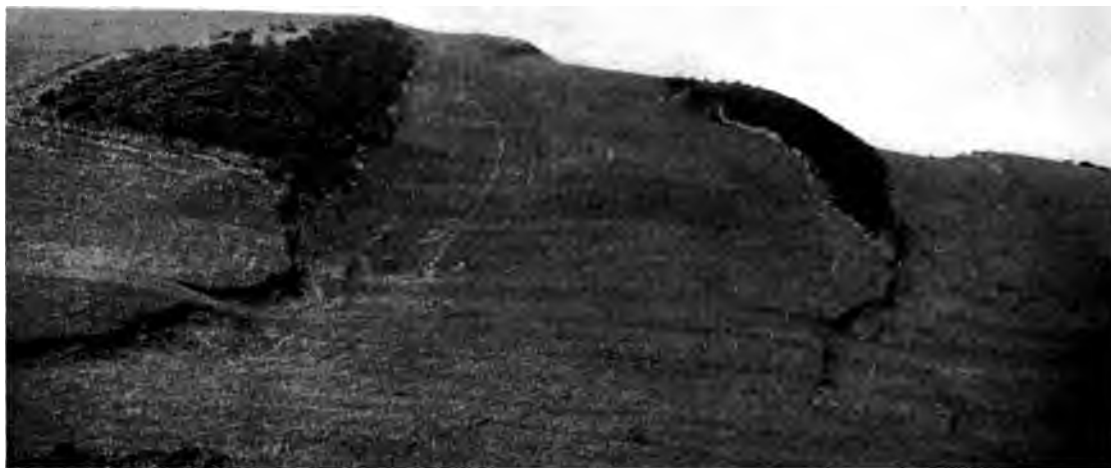
B. Roadside crack a mile southeast of Inverness. G. K. G.

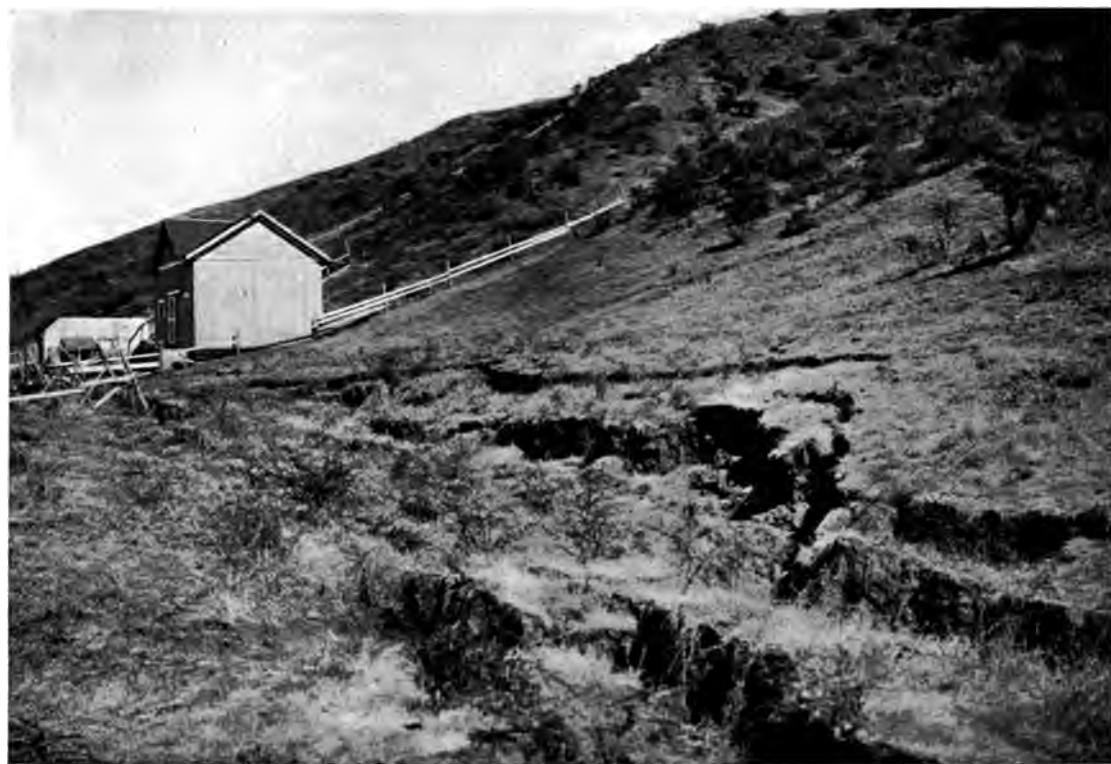
About 6 miles farther south, at the head of Pine Gulch Creek, another road crosses the range, and in following this a group of cracks was seen. A short distance west of the divide, and about a mile in a direct line from the fault-trace, is a fault-sag trending northwest-southeast. On each side of it a crack was seen, the eastern crack being the wider and showing a small throw to the southwest. This crack was traced for about 0.75 mile and found to curve thru an arc of nearly  $90^{\circ}$  from southeast to southwest. At its southwest end, or at least the southwestern limit of tracing, it is on a ridge, and it there expands into, or else is replaced by, a group of cracks diverging fan-wise. On each member of the group faulting took place, the downthrow being toward the northwest except in the case of two apparently short cracks with downthrow to the southeast. On four of these cracks the throw was greater than 1 foot, and at one place it was about 5 feet. Each crack was associated with a preëxistent bluff or scarp, indicating that earlier movements have occurred at the same place. The field in which the principal phenomena occur is cultivated with the exception of the steeper scarps, whose faces retain a bushy growth. (See plates 52A and 53A.)

A. Group of earthquake cracks southwest of head of Pine Gulch Creek. Looking southwest. Structure well indicated by sky line. Since dislocation field has been plowed and farm road graded up fault-scarps. Compare Plate 53 A. G. K. G.

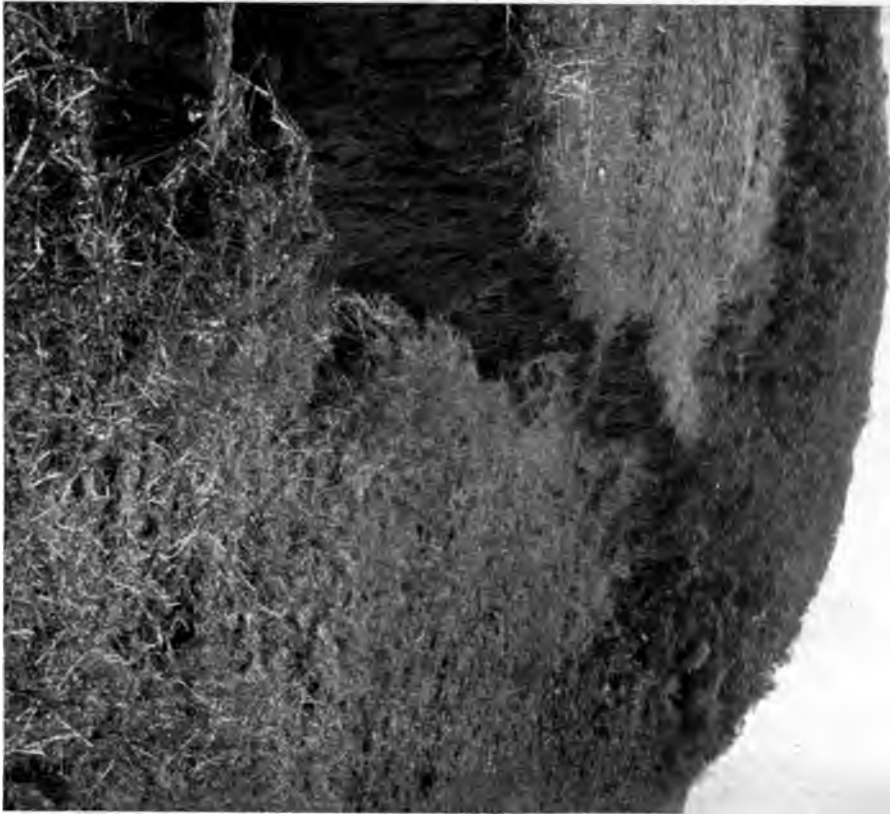
B. Earthquake cracks in Bolinas at edge of an earthquake sag. G. K. G.

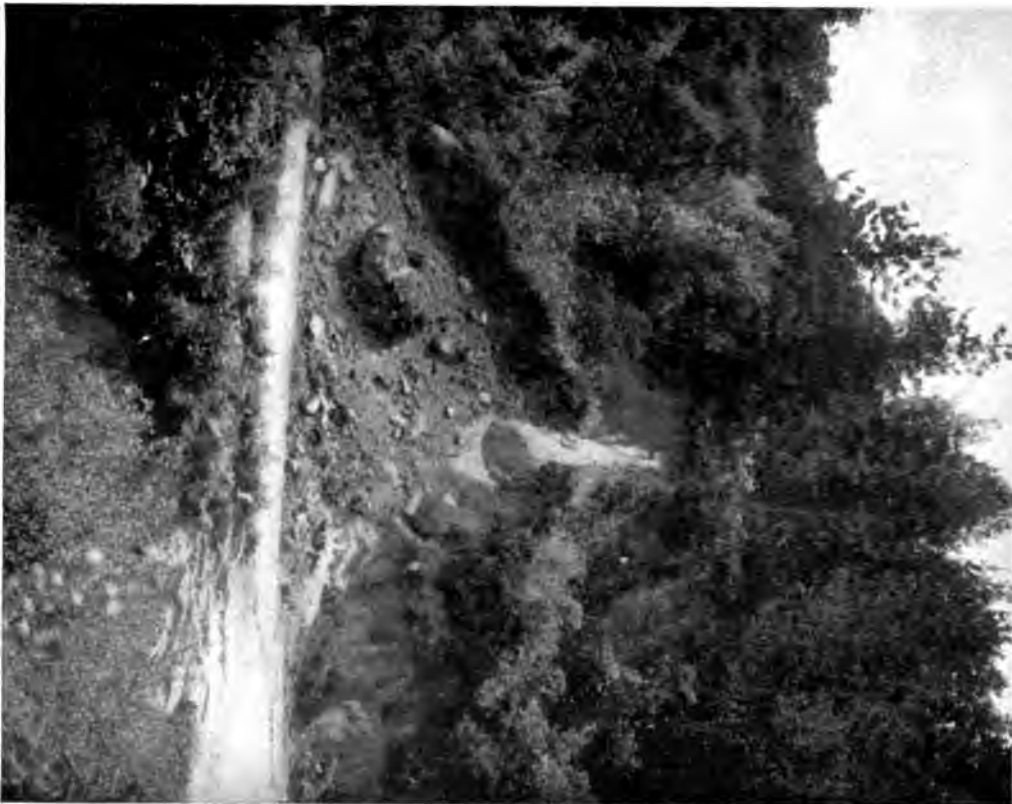
**A.** Fault-scarp on earthquake crack. Throw is about 5 feet. Compare Plate 52 A. G. K. G.

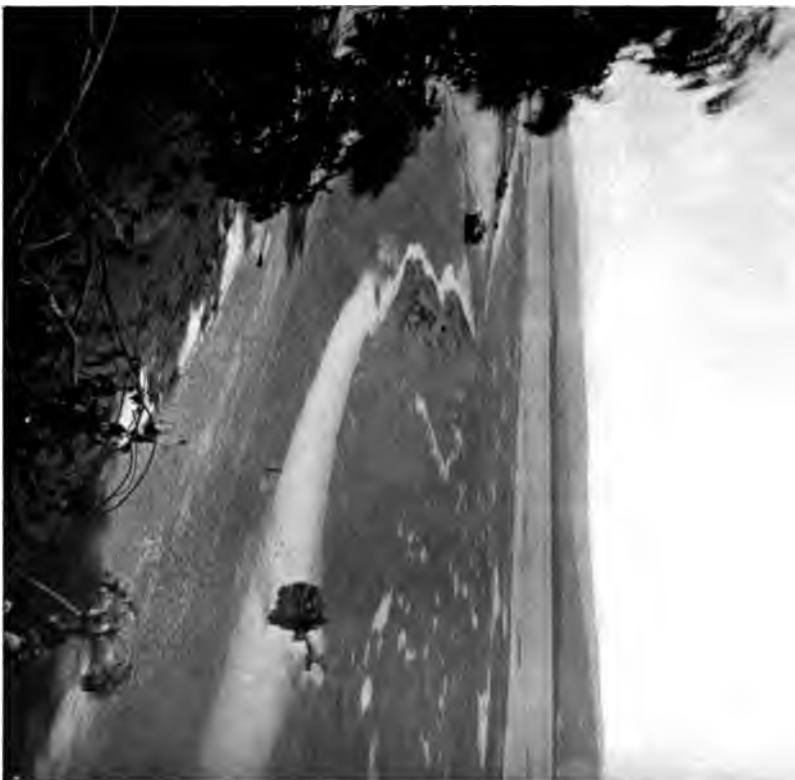
A. Landslides 2.5 miles northwest of Bolinas Lagoon. Looking northeast. Storm waters of 1907, guided by earthquake cracks, converted earth into soft mud. G. K. G.

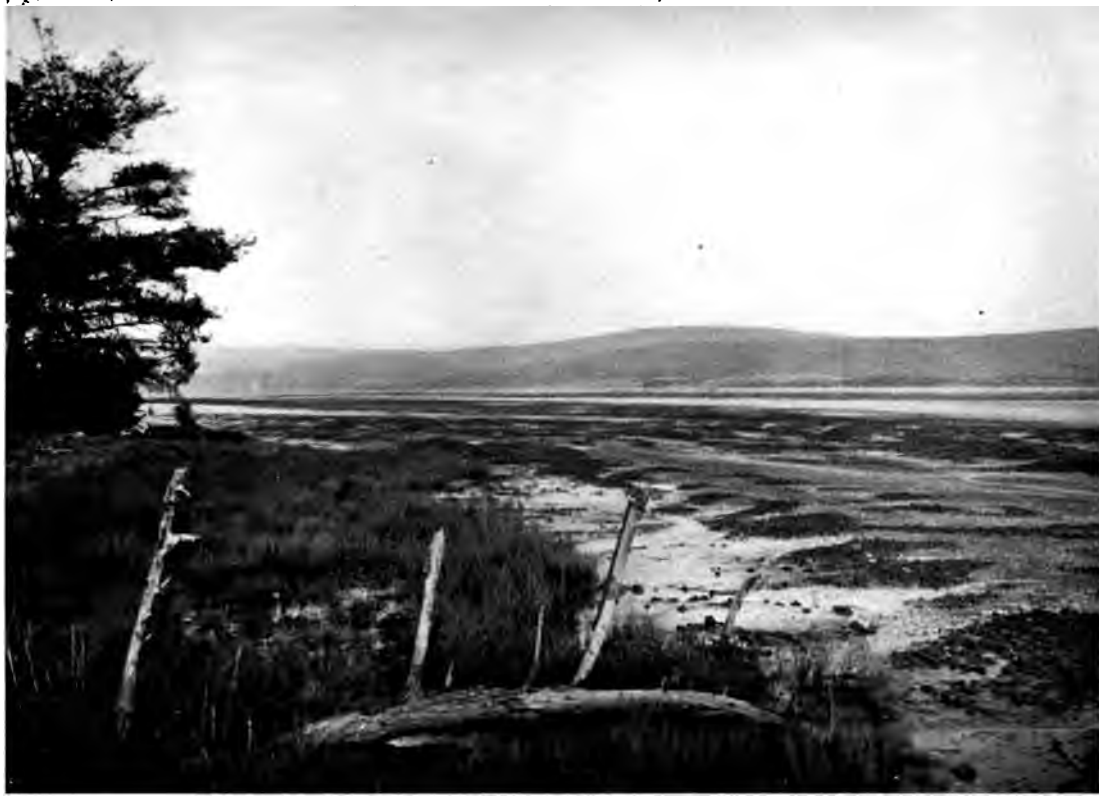
B. South part of Inverness shoal, at low tide, April 28, 1906. Looking north-northwest. Lane of water separates firm, gravelly beach from mud shifted shoreward by earthquake. G. K. G.

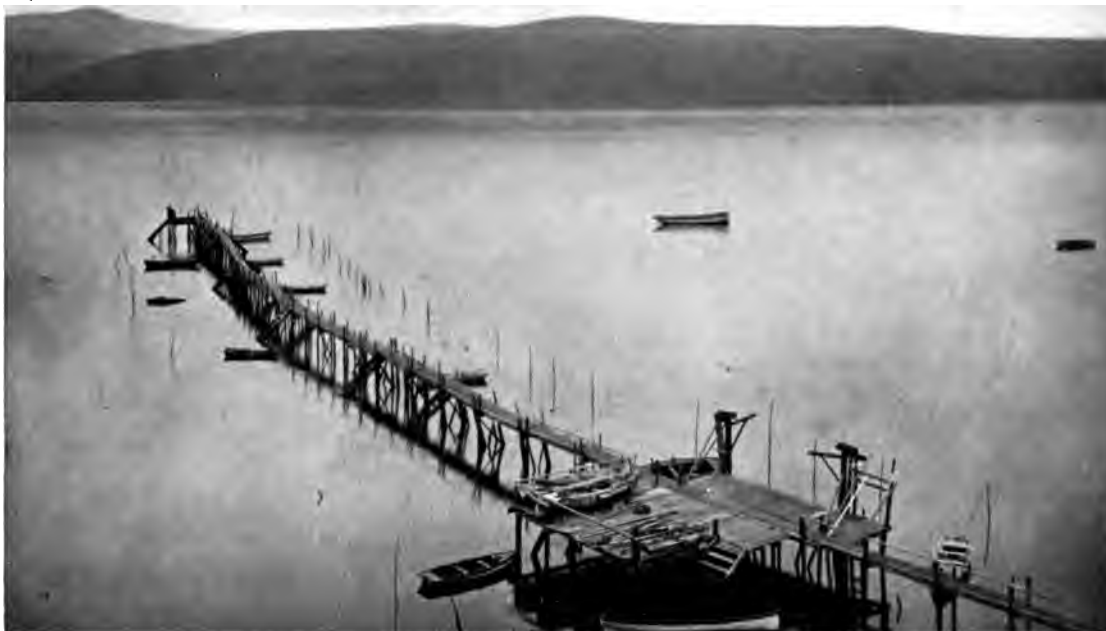
B. Bailey's pier at Inverness. Originally straight; shifted and much broken by earthquake. In subsequent repairs curvature caused by earthquake was retained. G. K. G.

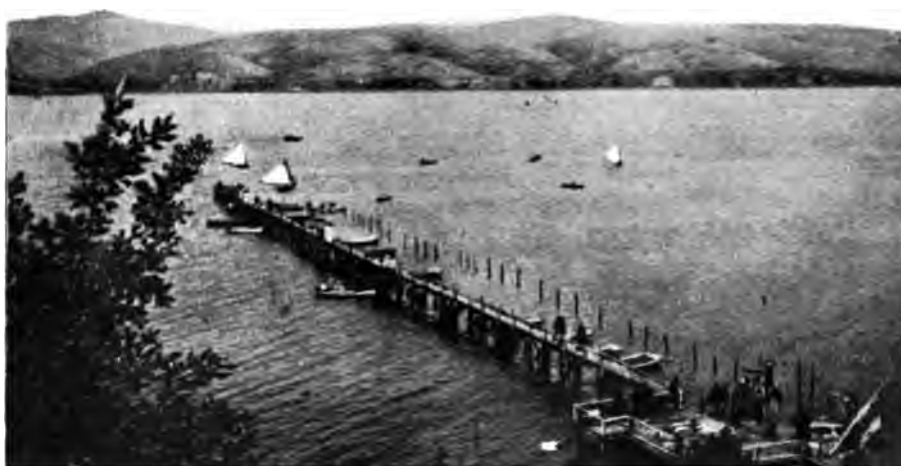
A. Bailey's pier at Inverness. Another view, position of camera being approximately same as in making photograph below, taken before the earthquake. G. K. G.

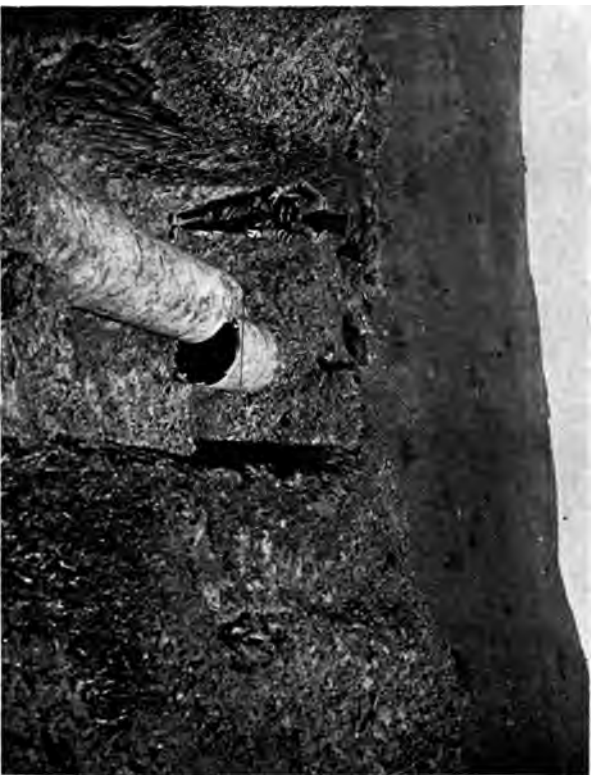
A. Offset in 30-inch water-pipe by fault. Northwest of San Andreas Lake. A. C. L.

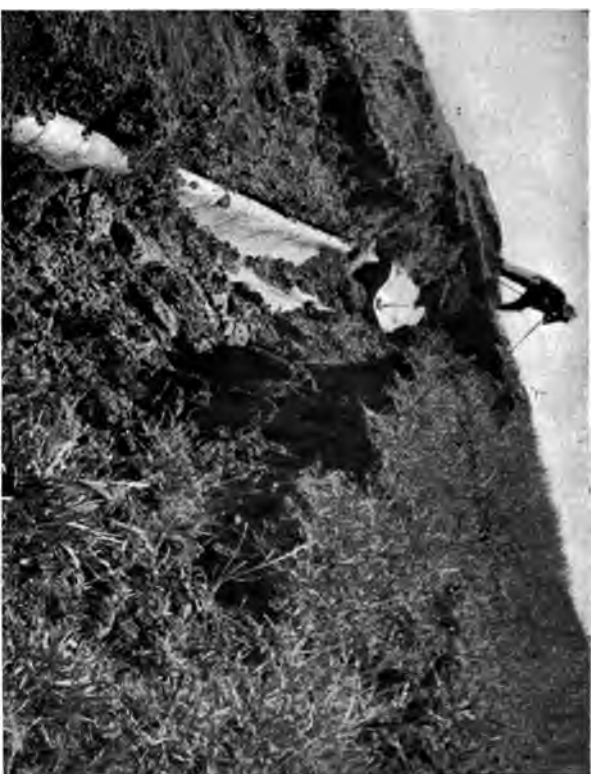
B. Collapse of 30-inch water-pipe northwest of San Andreas Lake. R. L. H.

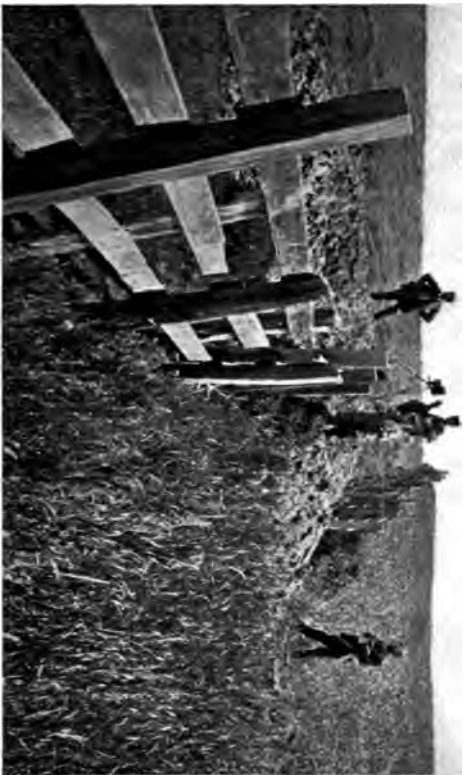
furrow. The movement was in the same direction as before, therefore a pulling apart of the pipe took place instead of a compression. There occurred two breaks in the pipe (see plate 59A), the main one at the crossing of the fault, and the other 150 yards away on the northeast side of the fault, but very near it, the pipe being almost parallel with it. At the main break, the pipe was pulled apart 59 inches, and at the other one 21.5 inches, making a total displacement of 6.666 feet. The pipe was not quite parallel with the fault and therefore there was a slight offset, at right angles to its direction, of 4 inches at the main break and 2 inches at the minor one, or a total of 6 inches. A fence which crossed the fault at the main break is offset 6.5 feet. (Plate 60c.)

C. Offset of 6.5 feet in fence, northwest of San Andreas Lake. R. L. H.

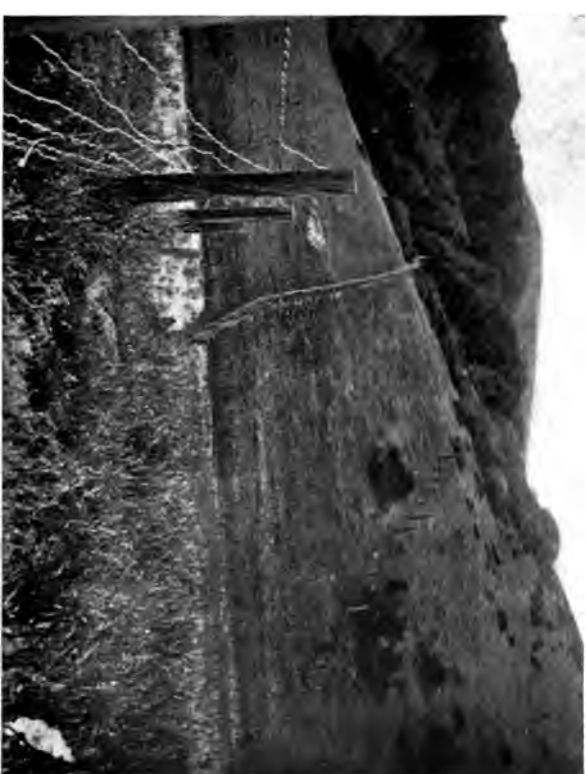
D. Offset of 6 feet in fence between San Andreas and Crystal Springs Lakes. Per J. O. B.

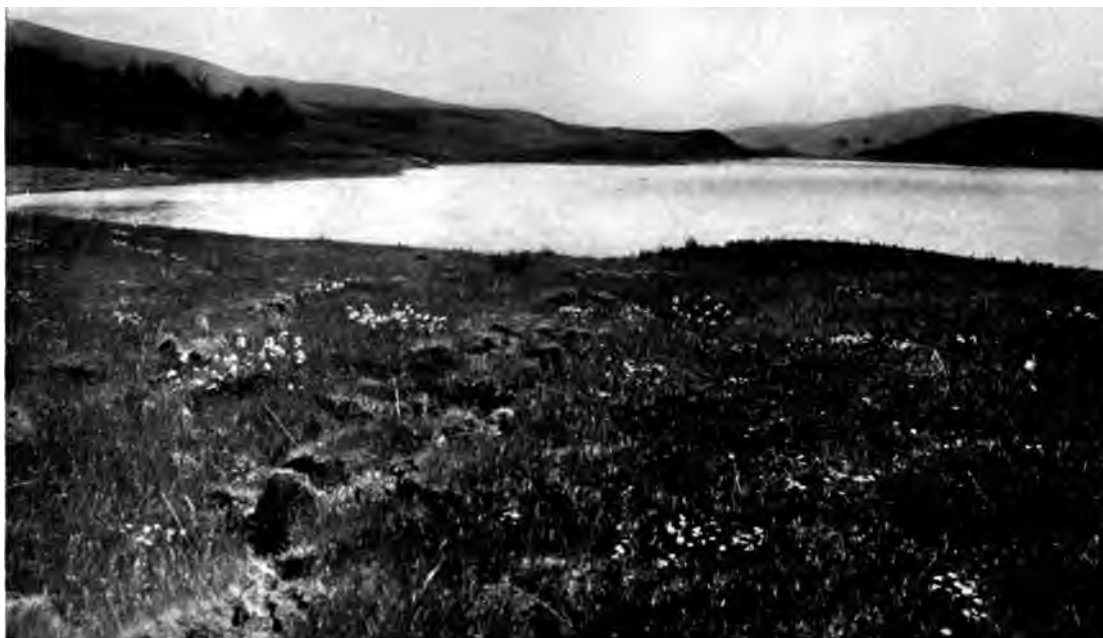
lake for the first 0.875 of a mile of its length. It then enters the water (plate 61D) and follows the northeast side of the lake, a little distance from shore, to the San Andreas dam at the lower end of the lake. In this distance of nearly 2 miles, the fault-trace emerges from the water at a number of points where little capes project into the lake. The crossing of these capes by the fault-trace indicates that it follows a very straight course beneath the water of the lake. On the last of these promontories traversed by the fault, the main fault-trace has associated with it a number of auxiliary cracks. Between the main fault-trace and one of the diverging cracks, on the southwest side of the fault, is a brick and cement gate-well in connection with the tunnel which takes the waters from the lake toward Millbrae. This gate-well was circular in cross-section, the inside diameter being about 26 feet. The nearest point of the structure to the main fault-trace is within 5 feet.

A. Fault-trace where it passes into San Andreas Lake. D.

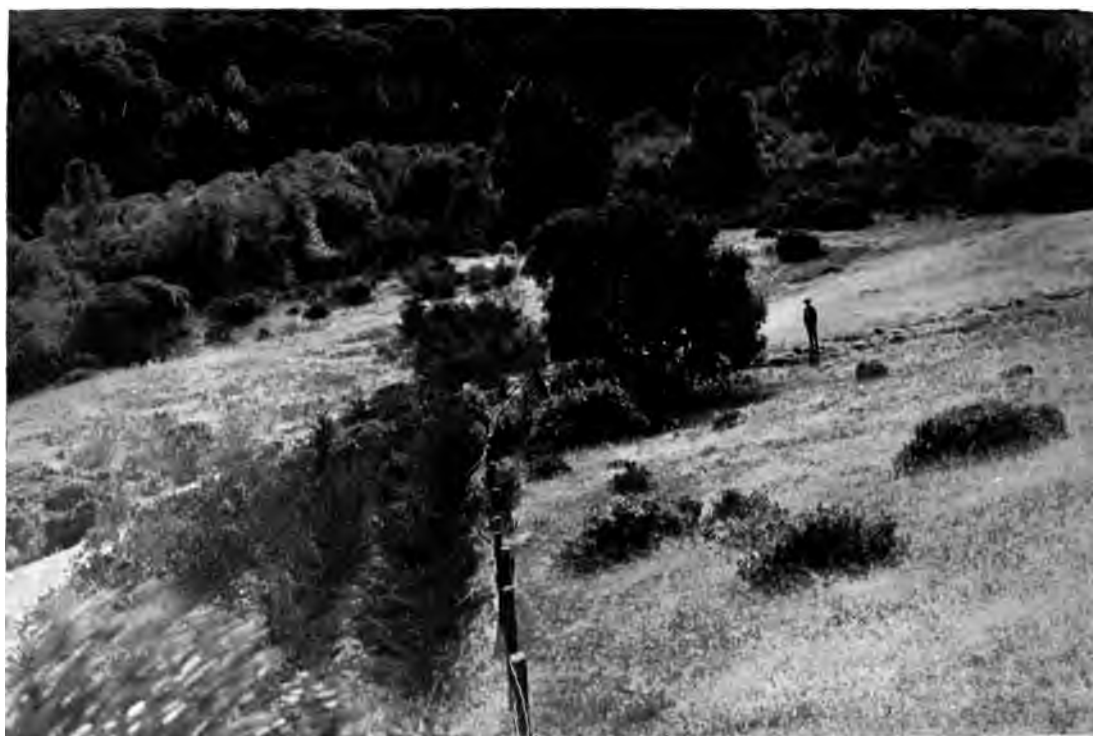
B. Offset fence near Crystal Springs Lake. B. A.

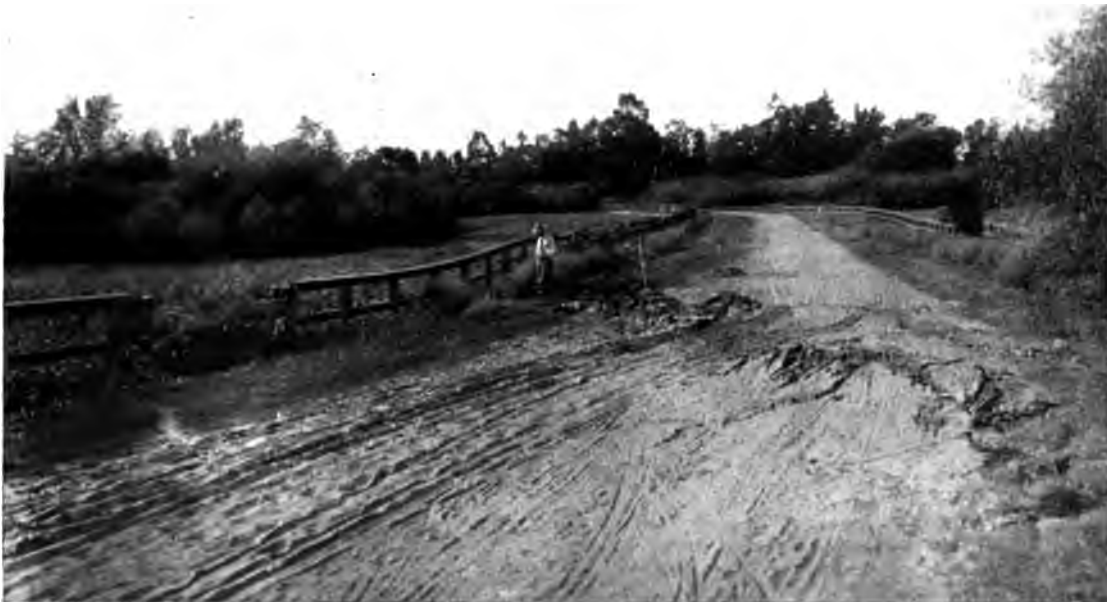
B. Offset of road by main fault near Searsville reservoir. Per J. O. B.

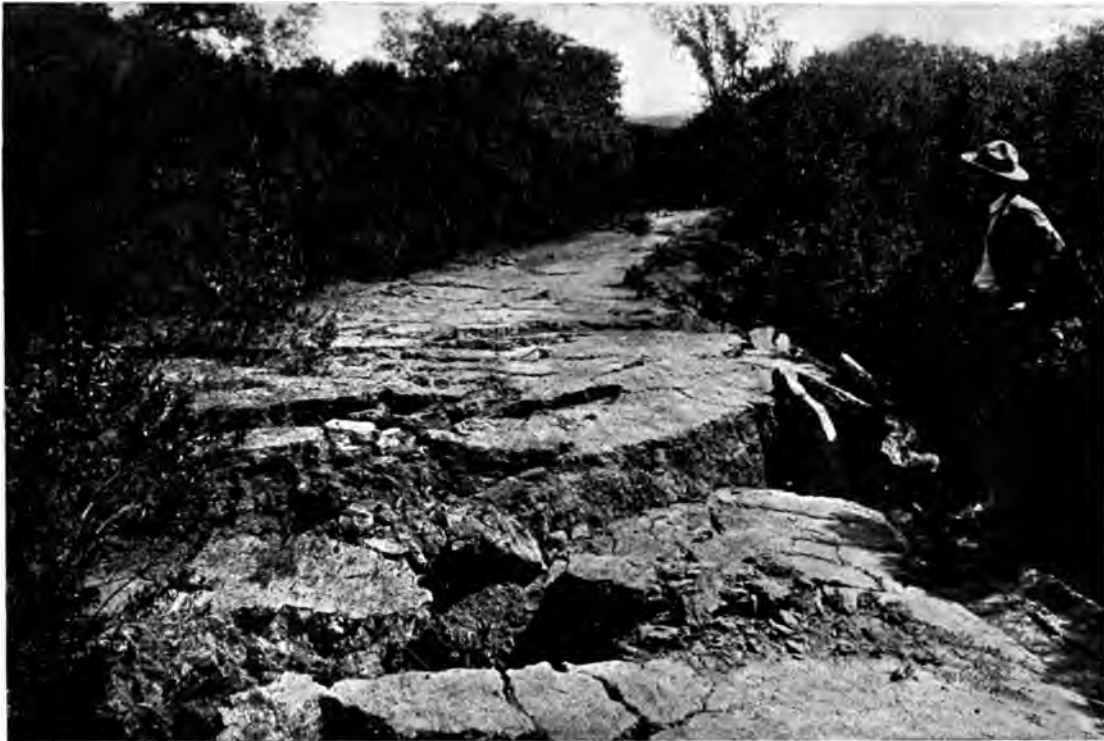
A. Offset of Alpine road 5 miles west of Stanford University. Per J. C. B.

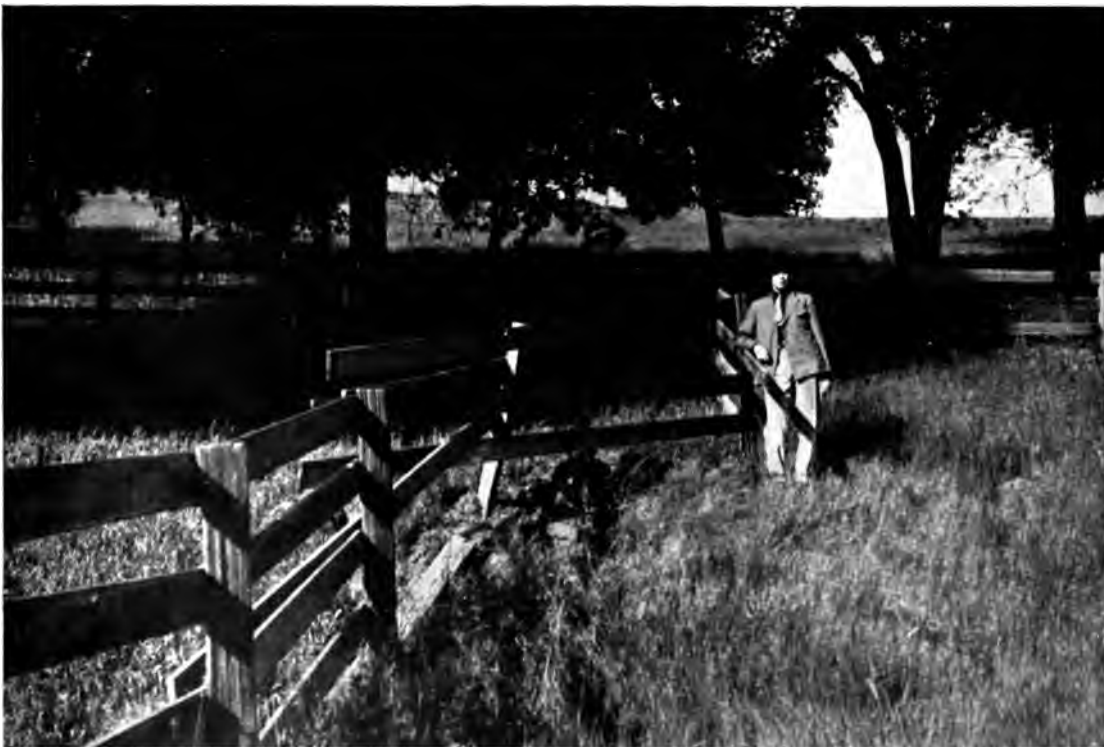
B. Offset of 8 feet in fence on Folger ranch, near Woodville. Per J. C. B.

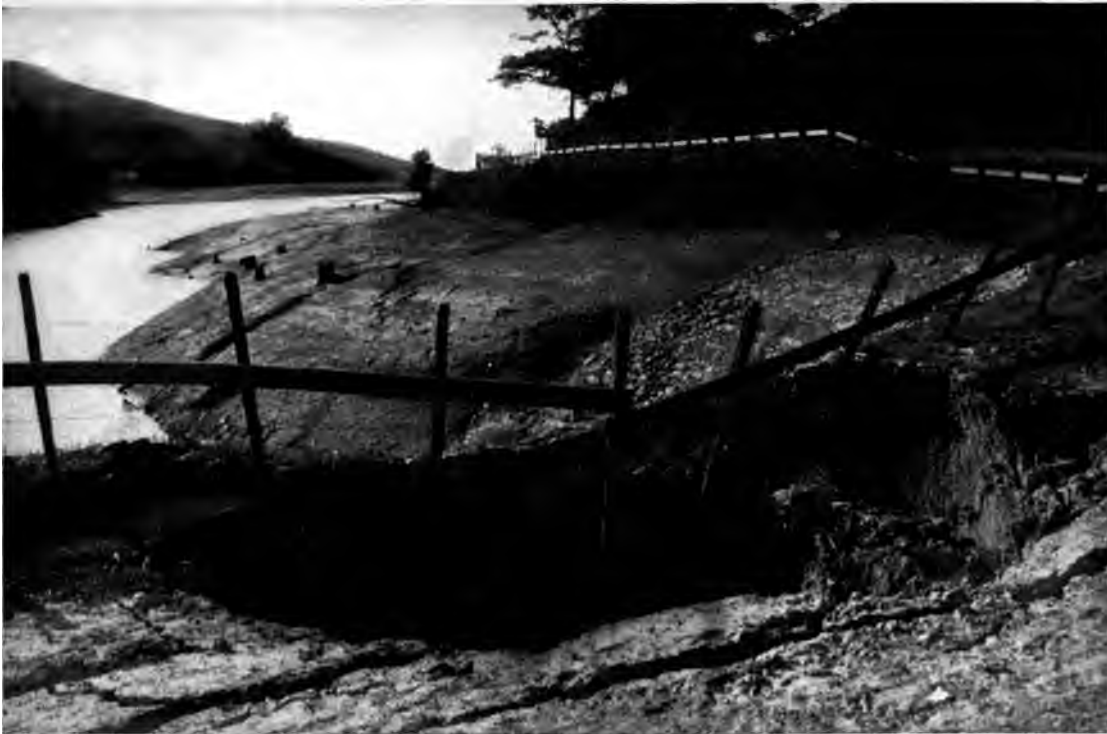
*South of Congress Springs.* — Near and northwest of the reservoir 2.5 miles southeast of Congress Springs, fissures from 4 to 6 feet wide ran nearly north and south, and past thru the earthen dam at the northwest end of the reservoir. (Plate 64A.) The intake pipes at the south end of the reservoir were disconnected, and the escaping water undermined a part of the southern dam of the reservoir. This reservoir is in a topographic saddle and has dams at both ends. The fault-trace passes thru this saddle. Where the bottom of the reservoir was exposed by the escape of the water, cracks of the fault-trace were exposed in the mud. Fences crossing the fissures showed but little displacement; the displacement moved the northeast side toward the southeast, relatively. The hills southeast of the reservoir have steep slopes of from 20 to 50 degrees. The cracks follow the east-facing slopes and the east side of these cracks had raised about 6 or 8 inches. Southeast of the reservoir the chimneys and water-tanks were down.

A. Reservoir in saddle south of Saratoga traversed by main fault. *D. D. D.*
